3.0 Canonsburg, Pennsylvania, Disposal Site

3.1 Compliance Summary

Figure 3-1. 2003 Annual Compliance Drawing for the Canonsburg, Pennsylvania, Disposal Site

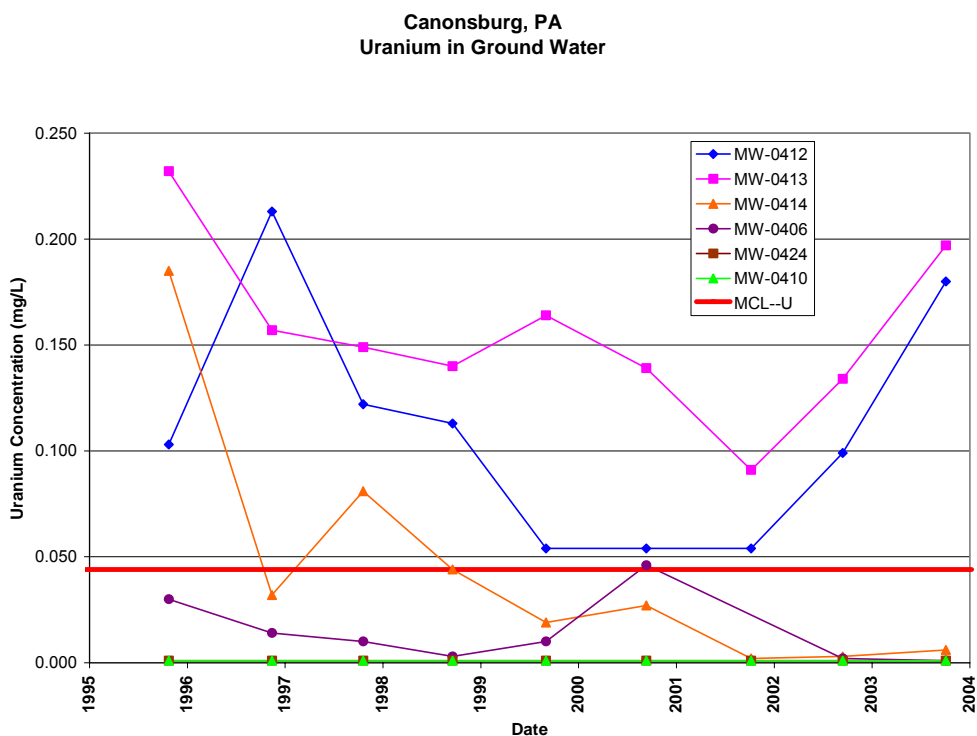
Figure 3-2. Uranium in Ground Water at the Canonsburg, Pennsylvania, Disposal Site

Uranium is the analyte of primary concern at this site because of the frequency with which it has exceeded its maximum concentration limit of 0.044 mg/L; time-concentration plots for uranium in ground water are shown in Figure 3-2. Uranium concentrations in ground water exceeded the standard at two of the downgradient wells (MW-0412 and MW-0413). Concentrations at these two locations have increased during the last 2 years and future results will be evaluated to determine if there is a trend. Uranium levels were substantially below the standard at the rest of the locations in 2003. Uranium concentrations were below the laboratory detection limit at all sampling locations in Chartiers Creek.

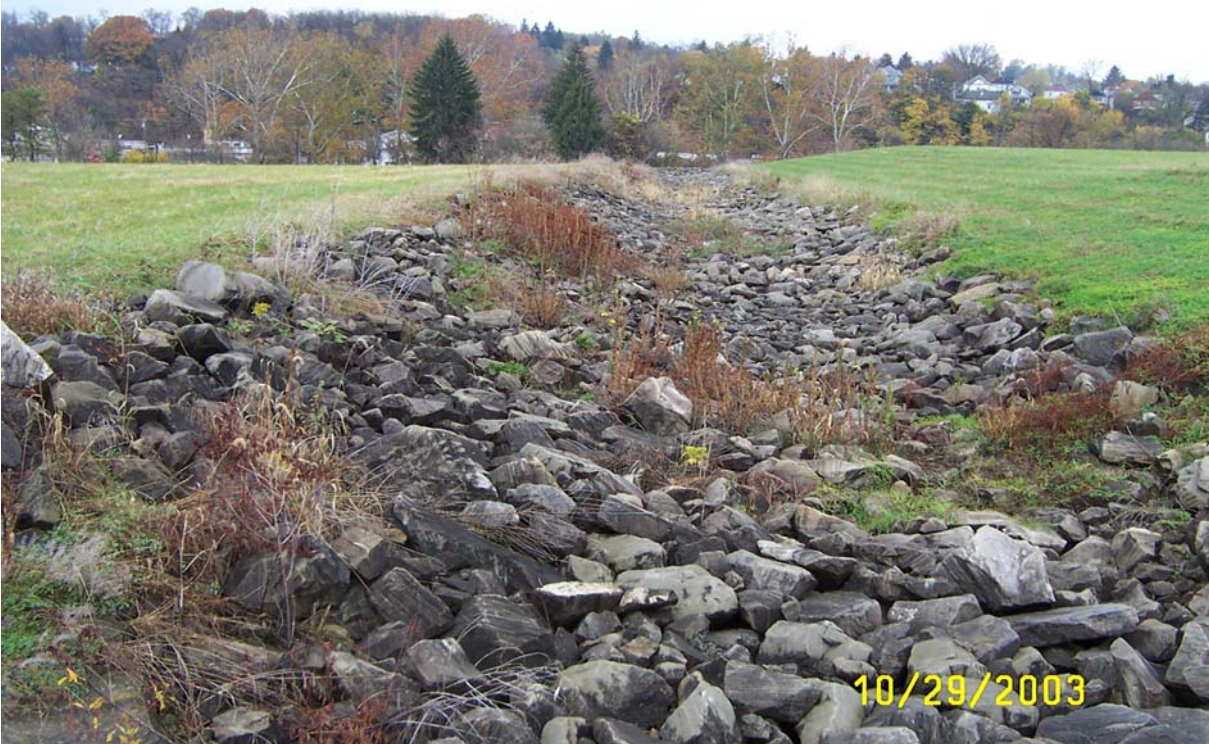
Vegetation in the diversion channels and perimeter ditch was treated with herbicide in 2002 and the dead woody plant material was removed in 2003. Some perennial vegetation, consisting primarily of grass-like plants, is re-establishing but currently is not impairing the function of the channels and ditch (PL-1).

CAN 10/2003. PL-1. Vegetation encroachment in the western diversion channel.

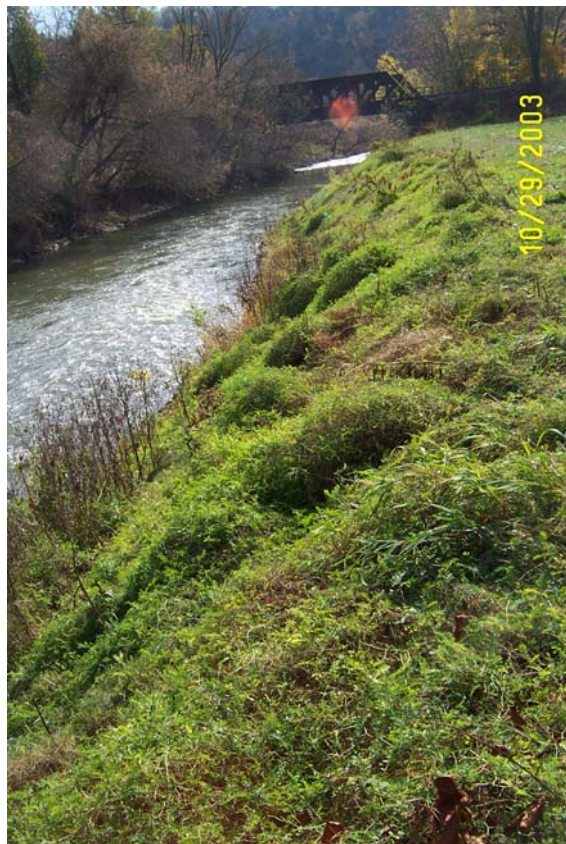
3E Erosion had occurred along the bank of Chartiers Creek at Area C after completion of remedial action. To correct this problem, DOE reconstructed and revegetated the bank between December 2000 and May 2001. The site inspection indicated that these efforts have stabilized the bank (PL-2). Seeded grass has established on the slope of the stream bank and native vegetation is establishing, but survival of willow plantings is limited mostly to the south end of the restored bank. DOE placed rock in a shallow erosion feature at the south end of the reconstructed bank earlier in 2003, and at the time of the inspection the area was stable.

CAN 10/2003. PL-2. The stabilized bank of Chartiers Creek along Area C.
